## **INSTALLATION INSTRUCTIONS**

SIDE BAR PART #204013 / 204013-2

2000 -12 GMC HD and 1500 CREW CAB 2/4WD  
2000 -12 CHEVY HD and 1500 CREW CAB 2/4WD

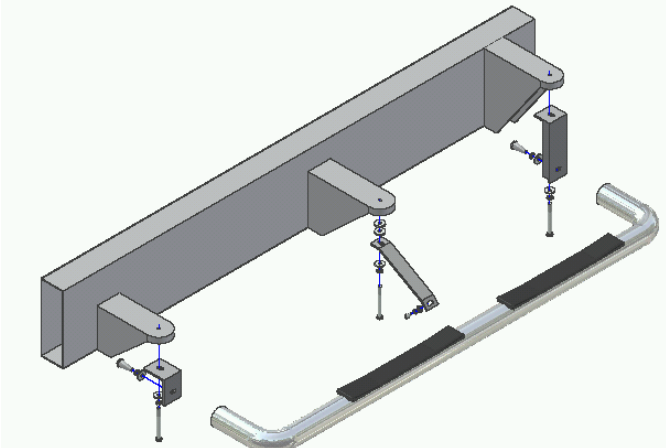
Figure 1.1 – Driver-Side Full Assembly View

1. Begin installation by working on driver side of the vehicle (see Figures 1.1 – 1.4).
2. From underneath truck, loosen and remove body mount bolts that run upward through mounts into floorboard. Attach and secure Front Mount Bracket to underside of vehicles front body mount, sandwiching the spacer tube shown (see Figure 1.2) with (1) M12 – 1.75 x 120mm bolt, (1) ½" split lock washer, and (1) ½" flat washer. Hand Tighten.

4. Attach Side Tube to Front and Rear Brackets using (1) ½" x 2" bolt, (1) ½" lock washer and (1) ½" flat washer for each bracket, and hand tighten. Fasten Center Brace to Side Tube using (1) 3/8" x 1" bolt, and (1) 3/8" flat washer. Adjust Side Tube so that it is level and centered, and tighten all bolts to complete the driver-side assembly.

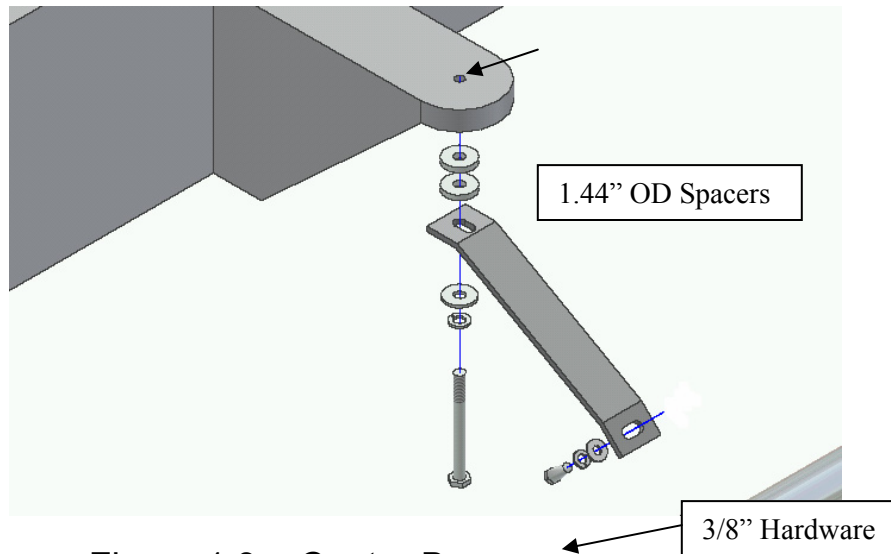
Figure 1.3 – Center Brace

3. Attach and secure Rear Mount Bracket to underside of vehicles rear body mount as shown in Figure 1.4, in same manner as the front. Repeat for Center Brace, but insert (2) 1.44" OD spacer washers between Center Brace and center body mount (see Figure 1.3).
